GROUP
Safety Recall Campaign

MODEL
2013-2015MY
Optima (QF)
2014-2015MY
Sorento (XMa)

NUMBER
SC197 (Rev 2, 01/05/2021)

HECU/ABS MODULE PARASITIC CURRENT DRAW TEST AND REPLACEMENT (SC197)

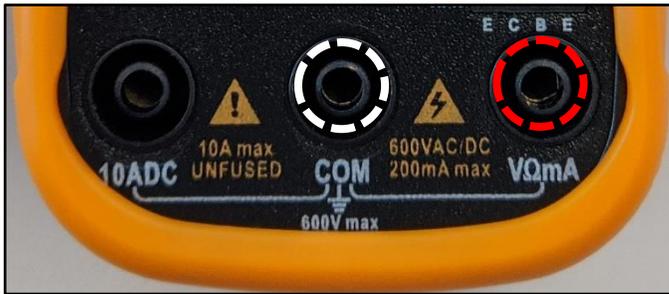
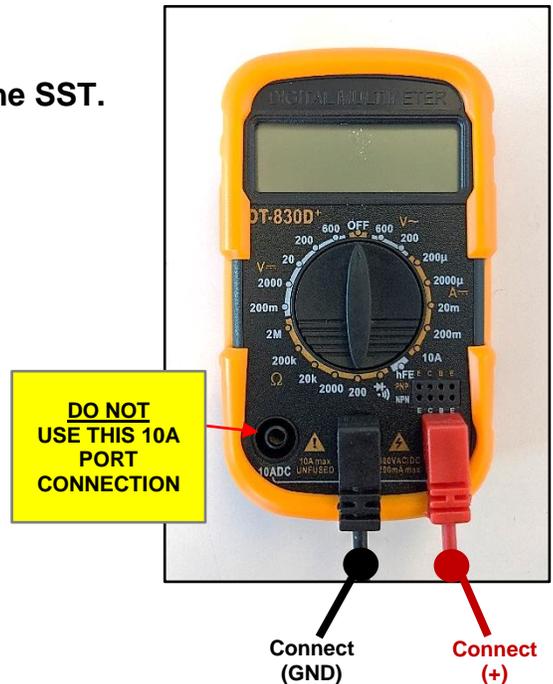
1. Connect two (2) lead wires (red and black) to the SST.

Black Ground (-) lead wire; connect to COM
Positive (+) lead wire; connect to VΩmA.

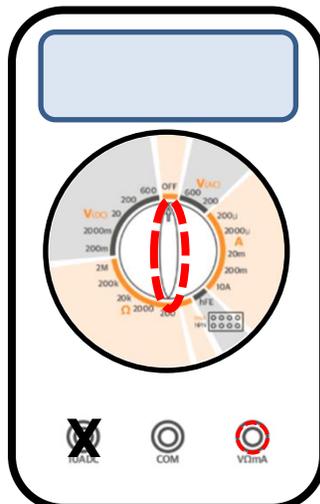
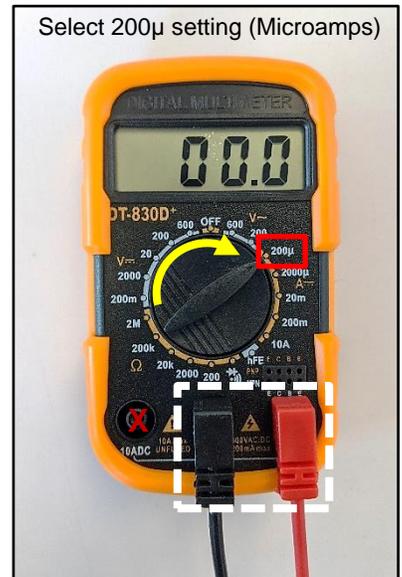
2. Turn the selection knob to the right and set it to **200uA**.

Meter Setting	Displayed Value
200uA	0 - 200
2000uA	DO NOT USE
10A	DO NOT USE

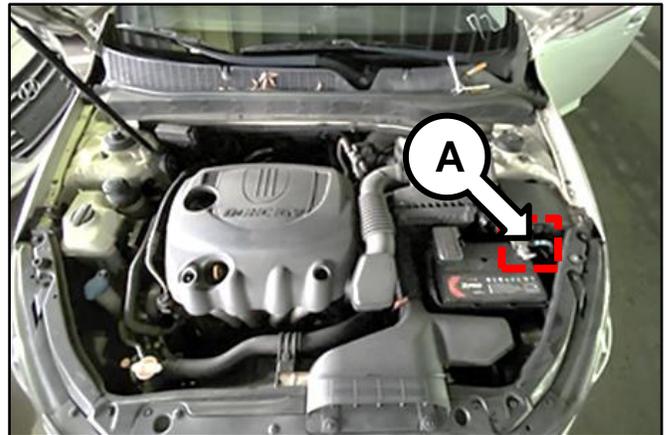
1. Open the hood and disconnect the battery negative (-) terminal (A).

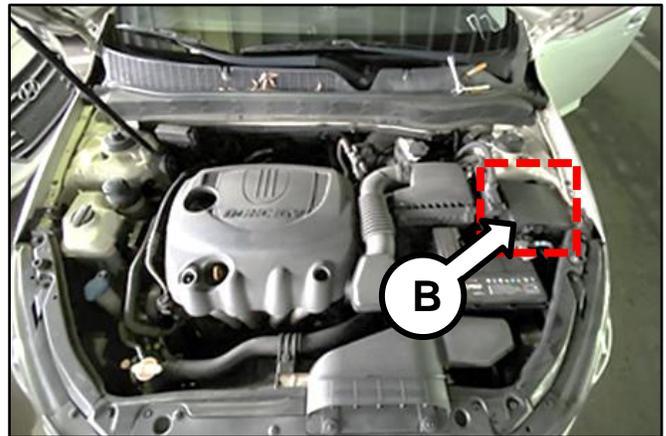
2. Remove the fuse box cover (B).

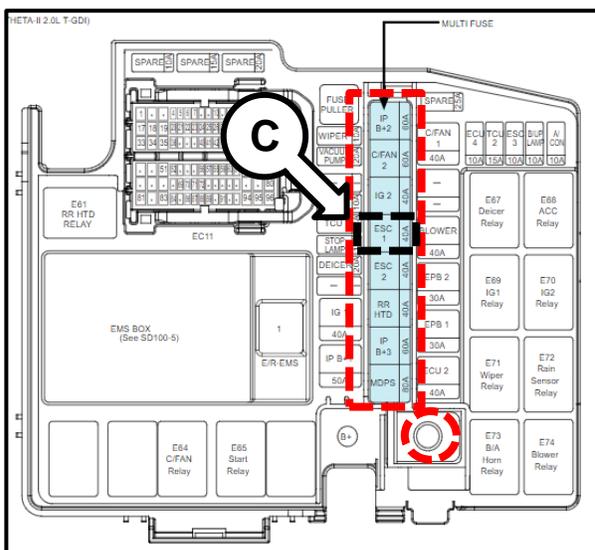
Optima (QF)

3. Locate the Multi-Fuse (C) ESC1 for (QF) Optima or ABS2 (XMa) Sorento 40A in the fuse box.

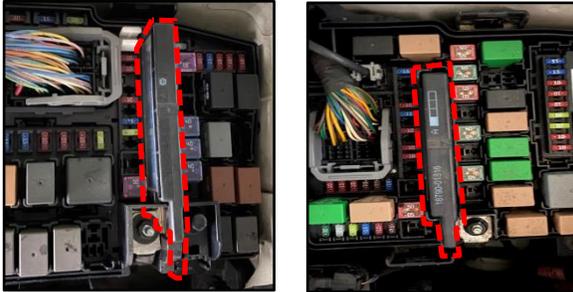
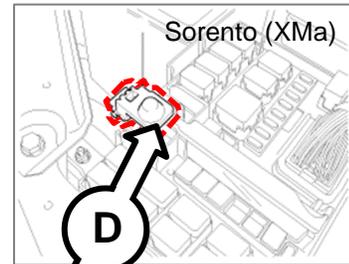
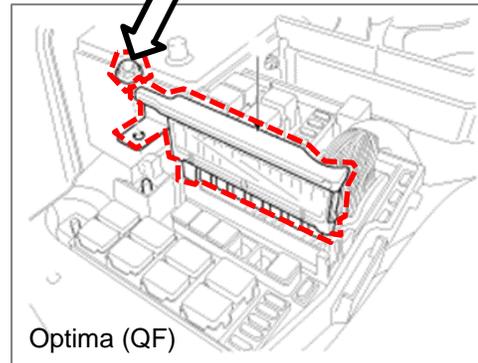
4. Loosen the 10mm Multi-Fuse retaining nut (D) and remove the Multi-Fuse.

Note: **Optima (QF) ONLY**, remove the nut cover first.

Sorento (XMA) ONLY, after removing the fuse, re-attach the 12VDC cable to the fuse box, and temporarily re-install the Multi-Fuse 10mm nut.

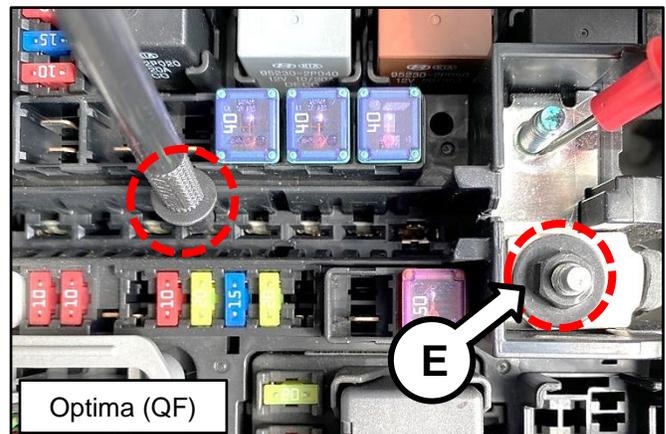
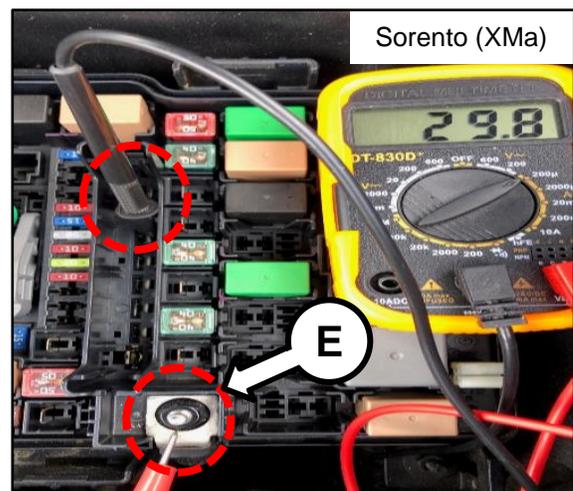
- 6a. Using the two (2) SST Multimeter jumper leads, **carefully** contact the **'black'** lead to the **'ESC1' (QF) OR 'ABS2' (XMa)** fuse terminal and the **'red'** lead to the fuse box **'Positive' (E) post**.

- 6b. **Measure the Multimeter value/reading for at least 15 seconds.** **Note:** The current draw value **must stay constant.** **DO NOT** damage the terminals.

If current draw value is OVER 70uA or 0.070mA, open a Techline case prior to part order, all part orders are on manual allocation. Replace the Hydraulic Electronic Control unit (HECU) by referring to the "Brake System → ESC (Electronic Stability Control) System → ESC Control Module → Repair procedures" chapter in the applicable Shop Manual on KGIS.

If current draw value is BELOW 70uA or .070mA, no further action is required. Reinstall the removed parts in the reverse order of removal.
